CASE HISTORY

Product: OILSCREEN®
Problem: Oily mist emissions
Sector: Non-Woven Fabric Production

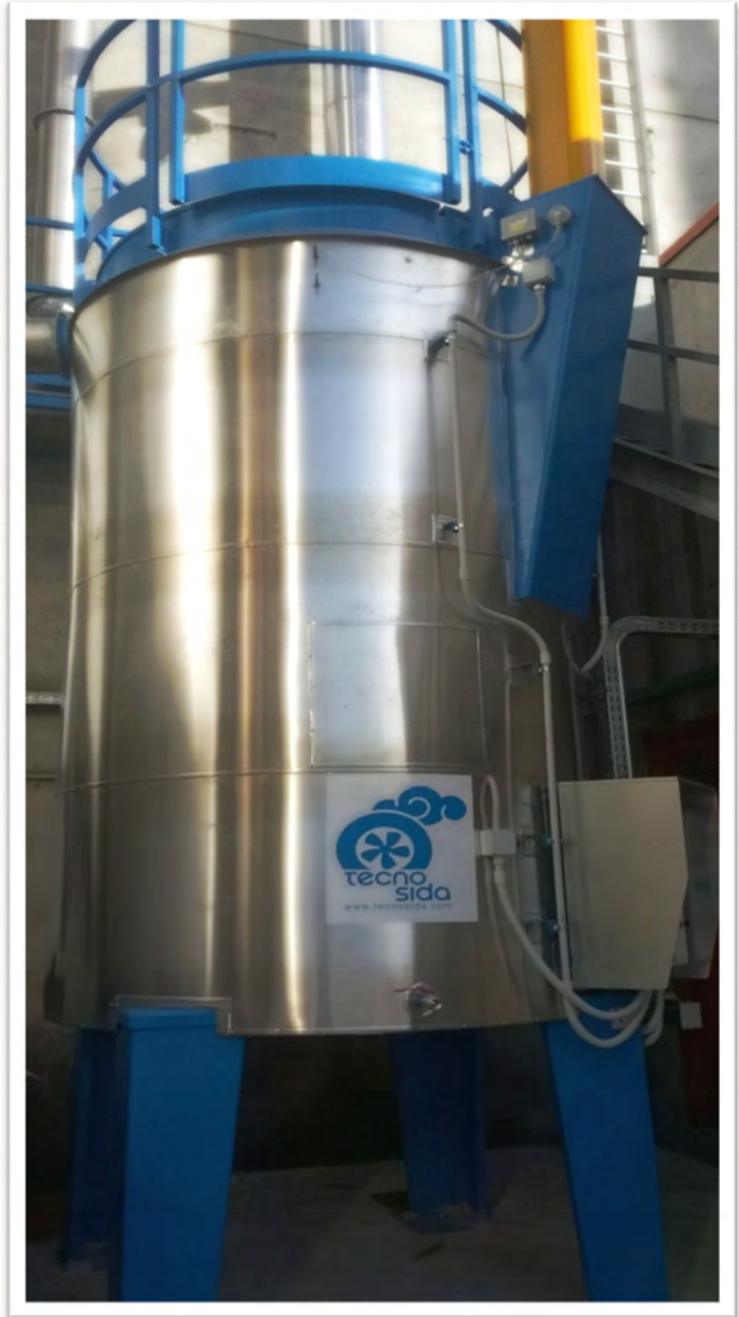
- To use the Oilscreen® filter with coalescence technology. The version for outside use in low temperature environments is equipped with a temperature regulator and special insulation to minimise the impact of the cold winter temperatures on the physical state of the effluent to be treated.
- The air to be treated is passed through insulated oil-tight external piping made of Aisi 304 stainless steel sheet with flanges.
- Installation of a jib hoist allows maintenance/replacement of the coalescent filter cartridges, which have an overall weight of more than 250 kg each in operation.
